## FINAL REPORT FOR ETP-0492, MEASURED RESIDUAL STRESSES IN CYL S/N 53 FRETTED AREA

NATIONAL AERONAUTICS AND SPACE ADMINISTRATION  
GEORGE C. MARSHALL SPACE FLIGHT CENTER  
MARSHALL SPACE FLIGHT CENTER, ALABAMA 35812

This test report presents the results of a residual stress survey of the inner clevis leg of lightweight cylinder S/N 053 as described by ETP-0492. The intent of this testing was to evaluate the residual stresses that occur in and around the fretting damage to the inner clevis leg at the capture feature contact zone during a normal flight cycle. Lightweight case cylinder segment 1U50717, S/N L053 from Flight STS-27 exhibited fretting around the circumferential contact zone of the inner clevis leg and the capture feature of the field joint. Post flight inspection revealed several large fretting pits on the inside of the inner clevis leg. This cylinder was assigned for both residual stress and metallurgical evaluation. This report is concerned only with the residual stress evaluations. The effects of glass bead cleaning and fretting were evaluated using the x-ray diffraction method.

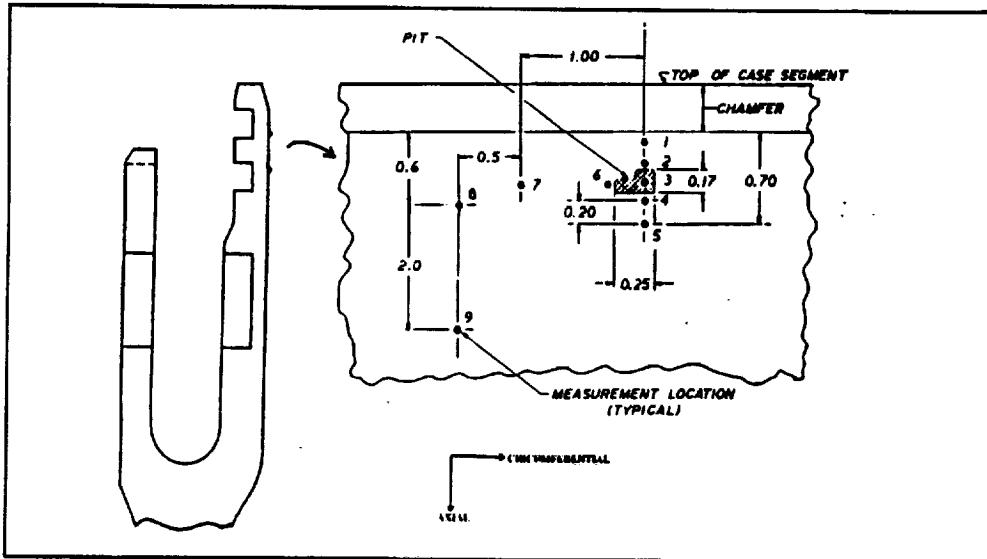
Figure 1 Layout of Primary Test Zone Showing Measurement Points

The RSRM cylinder segments are fabricated from D6AC steel per STW4-2606 and heat treated according to STW7-2608. Lightweight case cylinder segment 1U50717, S/N L053 from Flight STS-27 exhibited fretting around the circumferential contact zone of the inner clevis leg and the capture feature of the field joint. Post flight inspection revealed several large fretting pits on the inside of the inner clevis leg. This cylinder was then assigned for residual stress evaluation. Two large pits were selected for evaluation. The primary one was located at approximately the 288° angular position. The other was 8° away at 280°. Figure 1 shows local details of the primary pit and identifies nine points used in the evaluation. A tenth evaluation point was located near the center of the second pit. Figure 2 shows the orientations measured.

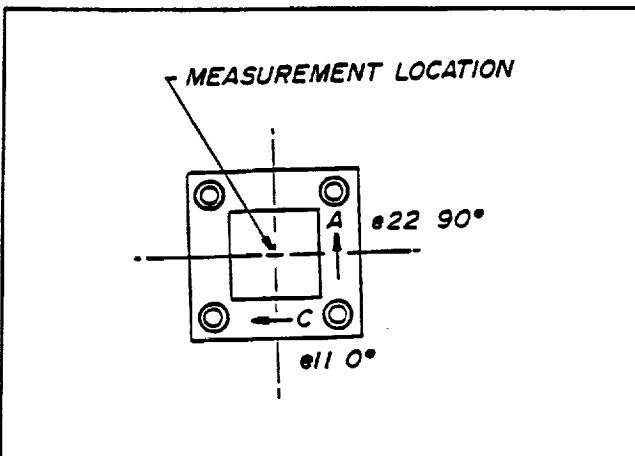
**Figure 3** Sample Used to Evaluate Effects of Glass Bead Blasting

This testing was done on the intact cylinder before any material was removed. A separate test coupon was used to evaluate the effects of glass bead blasting. This specimen was one of the typical 1 in. by 1 in. coupons excised from a scrapped case segment (not this test cylinder). A sketch of this specimen is shown in Figure 3. The residual stresses in this sample were assumed to be representative of those induced in a case surface during glass bead cleaning.
